Infrastructure and Projects Committee

Notice of Meeting

A meeting of the Infrastructure and Projects Committee will be held in the Council Chamber, 156 High Street, Dannevirke on **Wednesday 15 April 2026** commencing at **9:30am**.

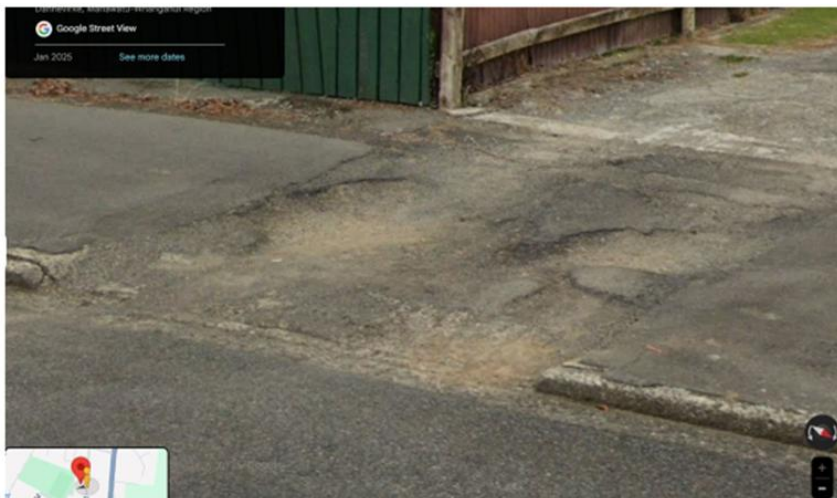
Image of the Vehicle Entranceway related to a CRM received on the 26th of March 2026

To meet Council's duty-of-care obligations, and as an interim measure, the Urban team has been instructed to undertake temporary or make-safe repairs where necessary to address immediate safety risks. These works are intended solely to manage risk and maintain pedestrian safety and accessibility and should not be interpreted as Council accepting full or ongoing responsibility for vehicle entranceway assets.

Where a vehicle crossing is assessed as being in a bad or unsafe state of repair, Council may, in accordance with the Traffic and Road Use Bylaw, issue formal notice requiring the owner or occupier of the land to repair, reconstruct, or renew the crossing to Council's satisfaction. Council will also review remaining vehicle entranceway faults and, where they pose a risk to footpath users, undertake make-safe works and issue notices as appropriate.

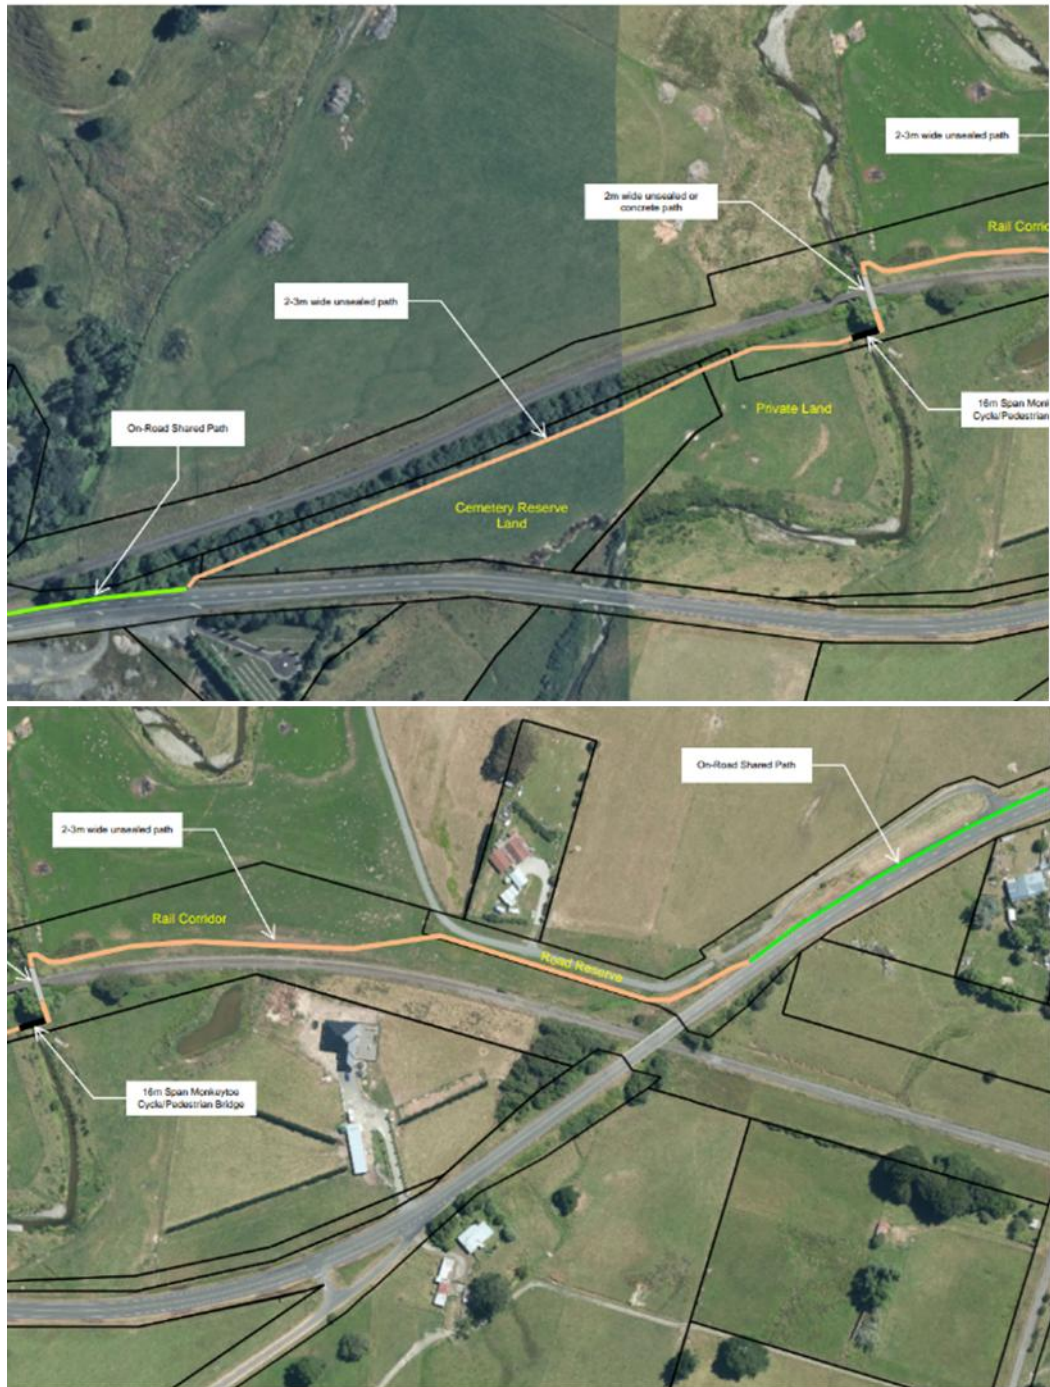
Proposed pathway between the Woodville Roundabout and the Woodville/ANZAC Cemeteries.

Below are the revised pathway and associated bridge. Once we have confidence from both Horizons and KiwiRail, we can commit to the purchase of the bridge and commence construction.

With the very tight budget provided to us through the Te Ahu Au Turanga project, our focus is to have the bridge and works within the rail corridor completed, and as much of the pathway off the road corridor as possible, with the remaining Shared Pathway to Ferry Reserve as a discussion point with NZTA as part of the SH3 and Gorge Revocation works.

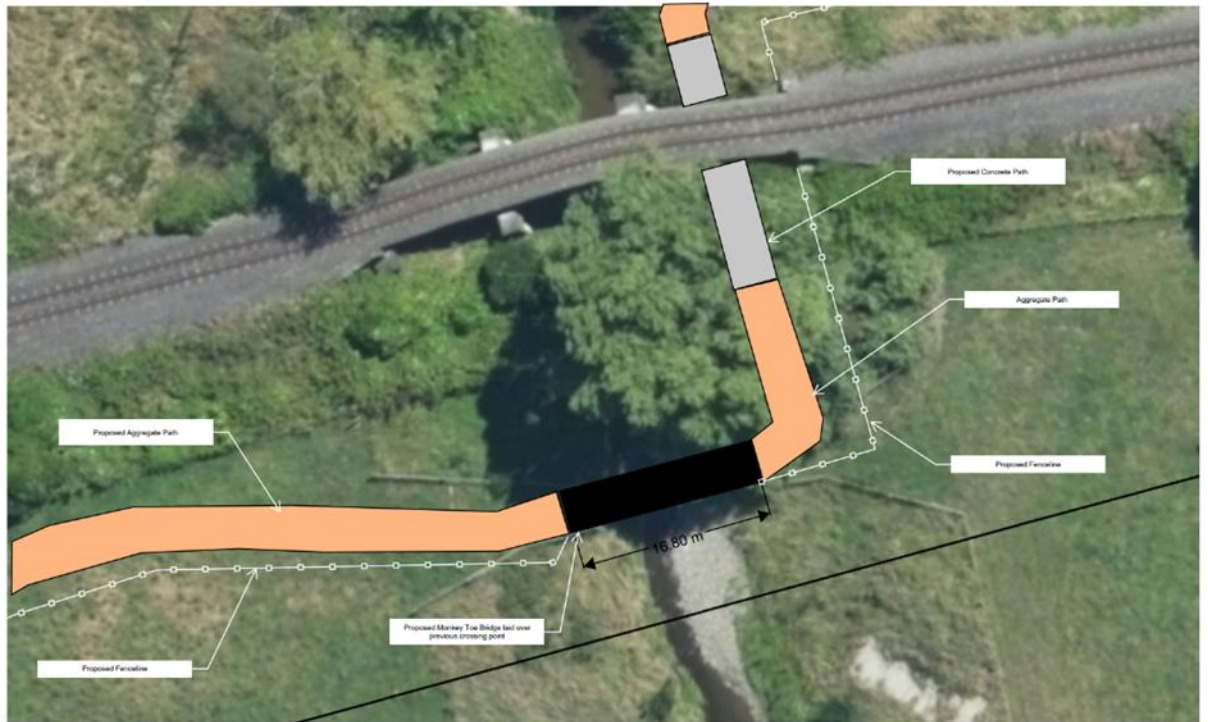
Proposed pathway under rail bridge and across the Mangamania Stream.

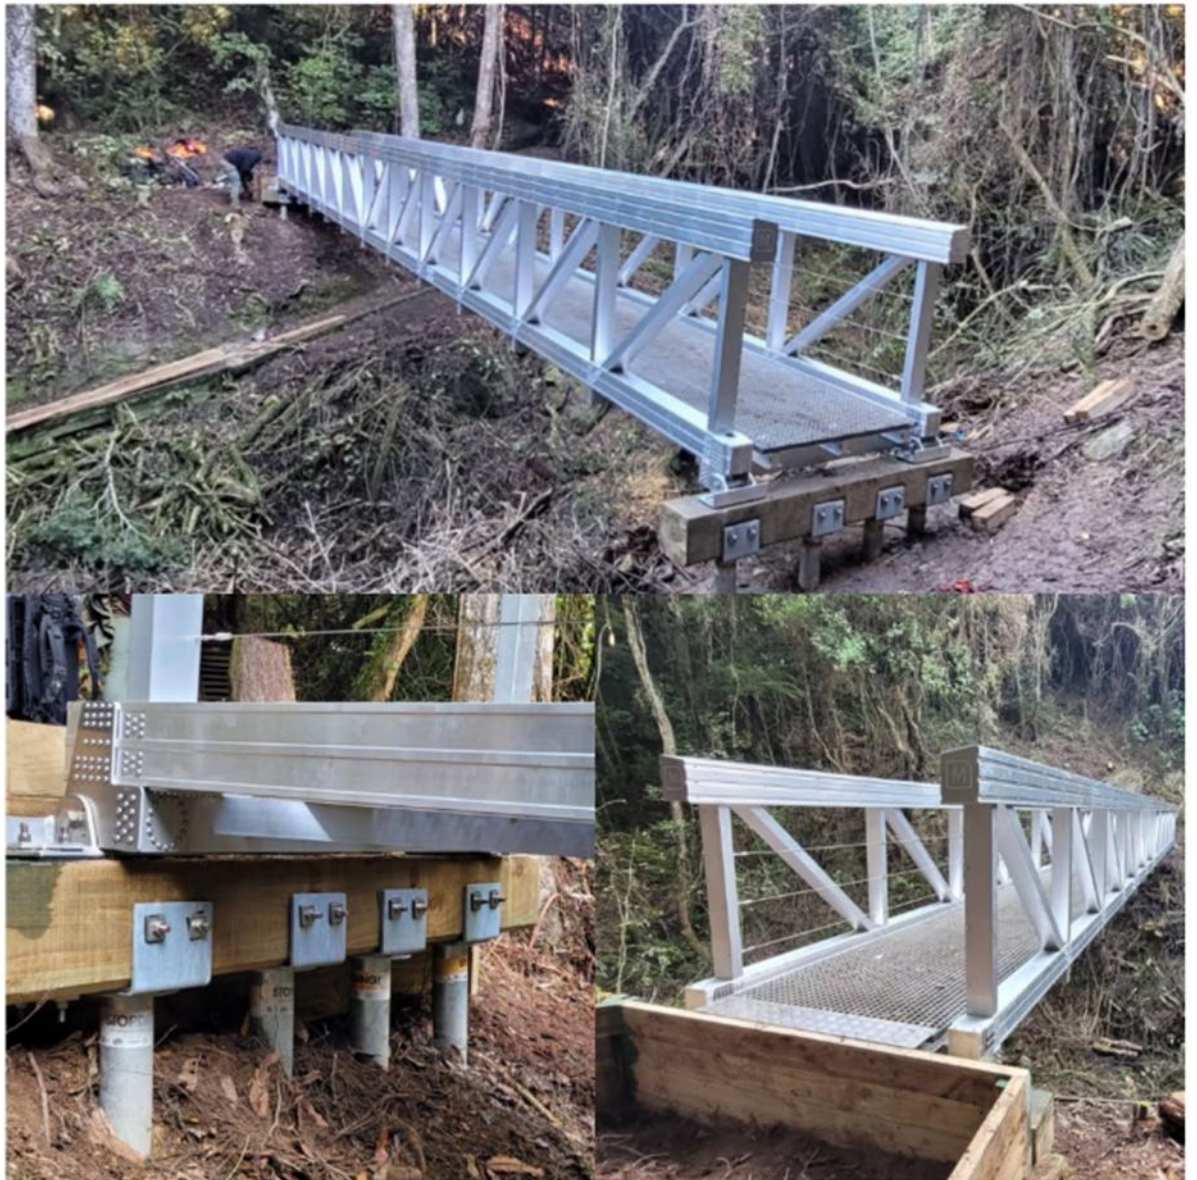
Proposed bridge across the Mangamanaia Stream.

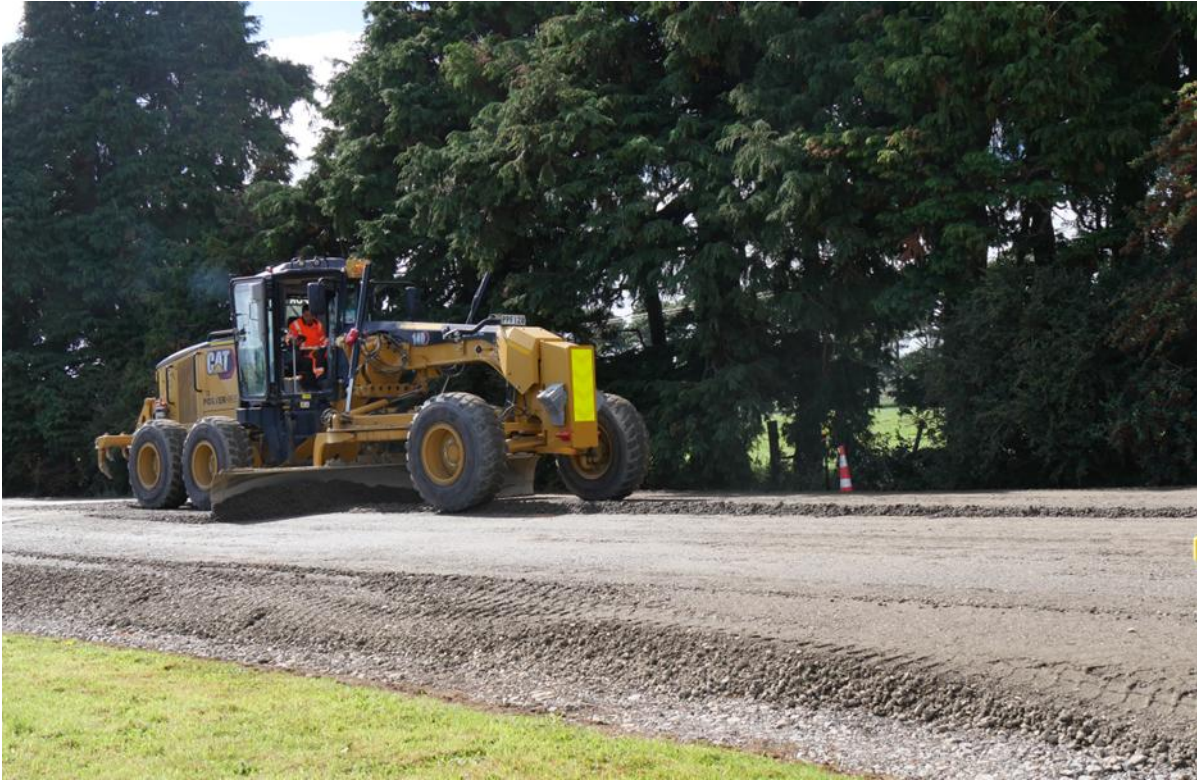
Tararua Alliance Rehabilitation team grading on Top Grass Road.

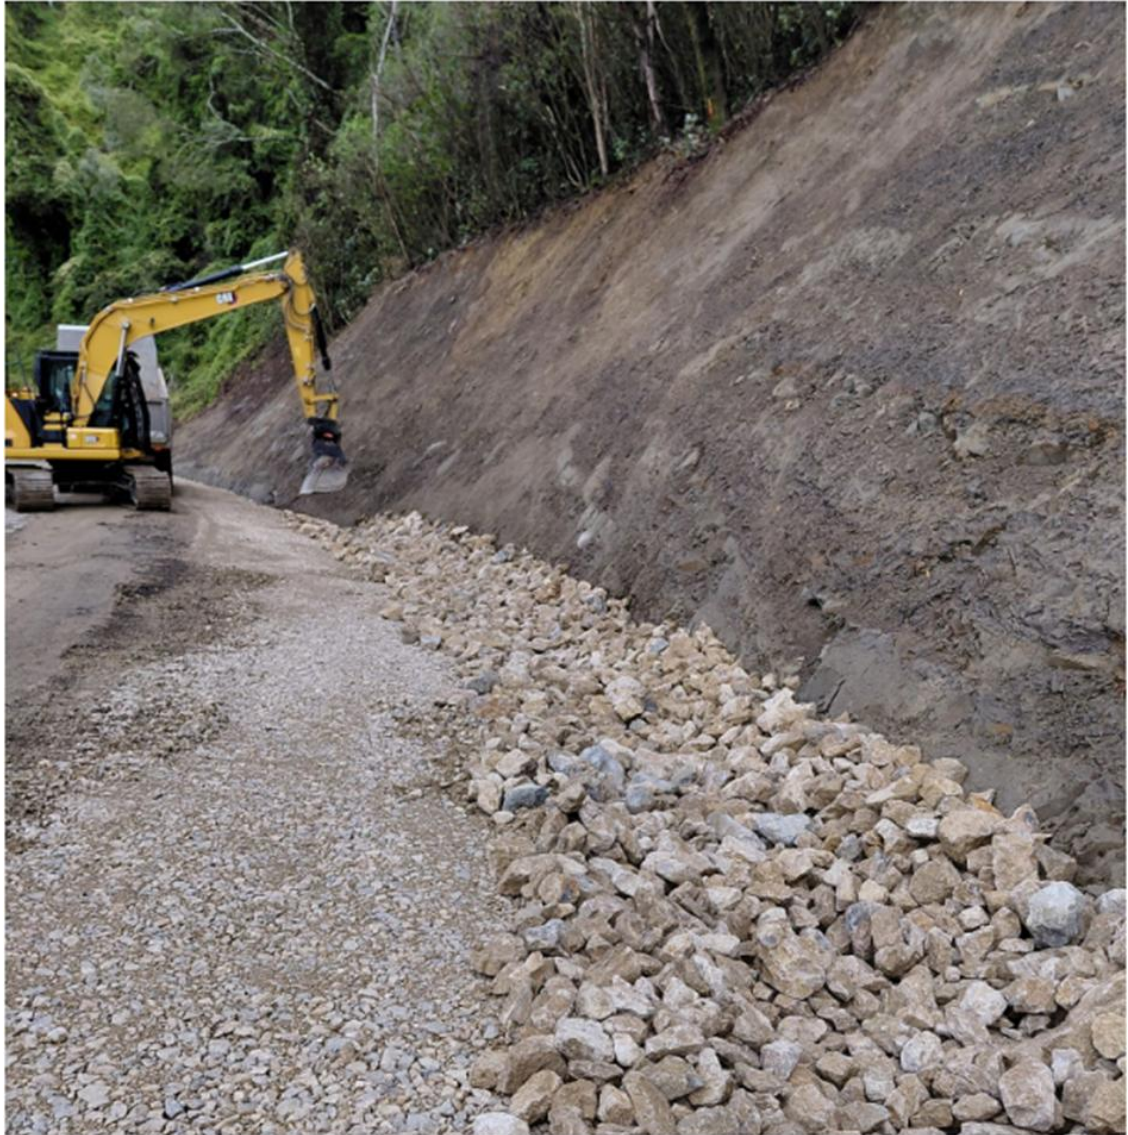
The Tararua Alliance emergency works team have been closing out work on Otanga Road and Maunga Road. The team is currently working on Coast Road at the 4km (Gun Club corner) where they are doing a slight retreat, a MSE (Mechanically Stabilised Earth) wall, drainage renewals and a pavement overlay.

Coast Road 4km retreat, planned construction completion end of April 2026.

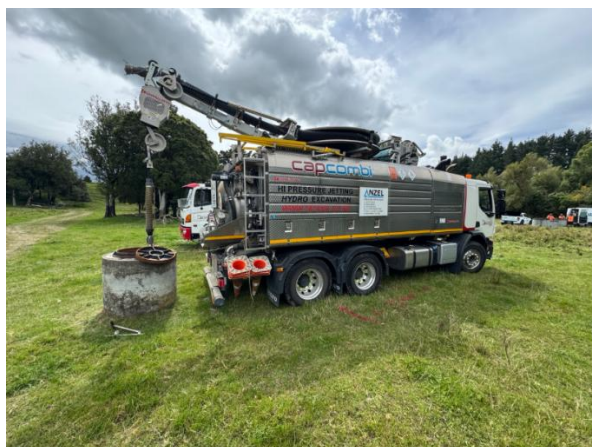
At the Dannevirke infiltration gallery, Tatana Contracting was engaged between 23 Feb to 9 Mar to execute CCTV, flushing and joint repair works. The work was carried out to rehabilitate and reassess the condition of our gallery, as part of enhancing the resiliency of our Dannevirke raw water intake infrastructure. The team will be reviewing the CCTV footages and reports to update our assets systems and identify any potential issues to be addressed.

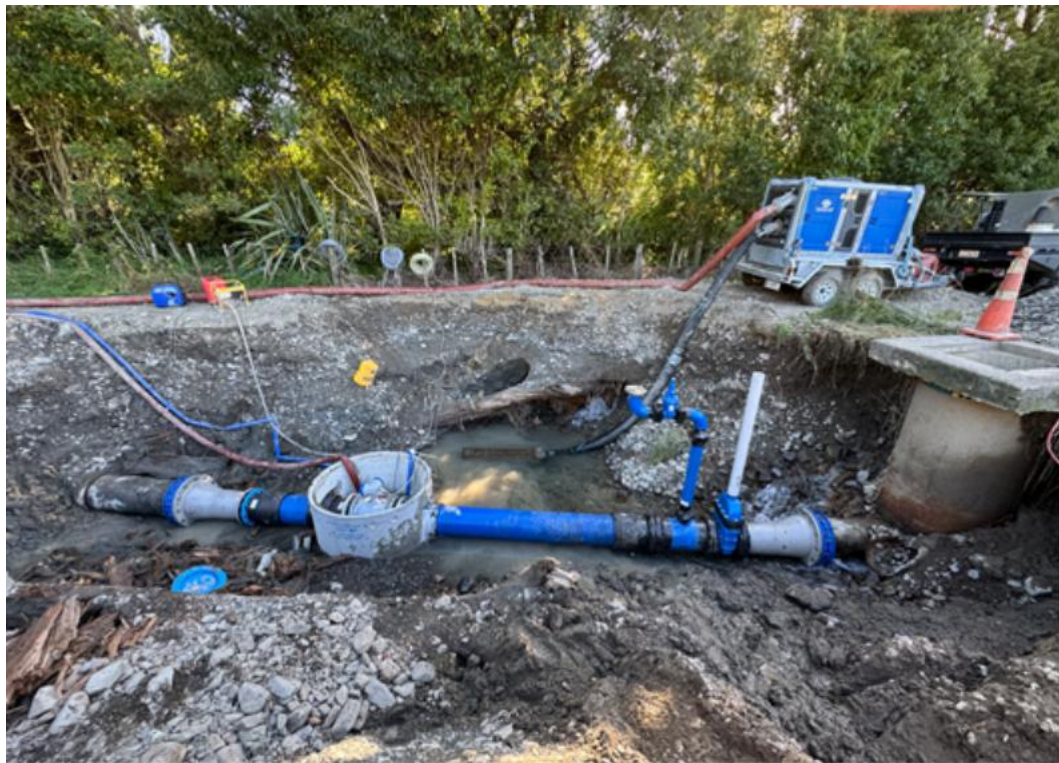
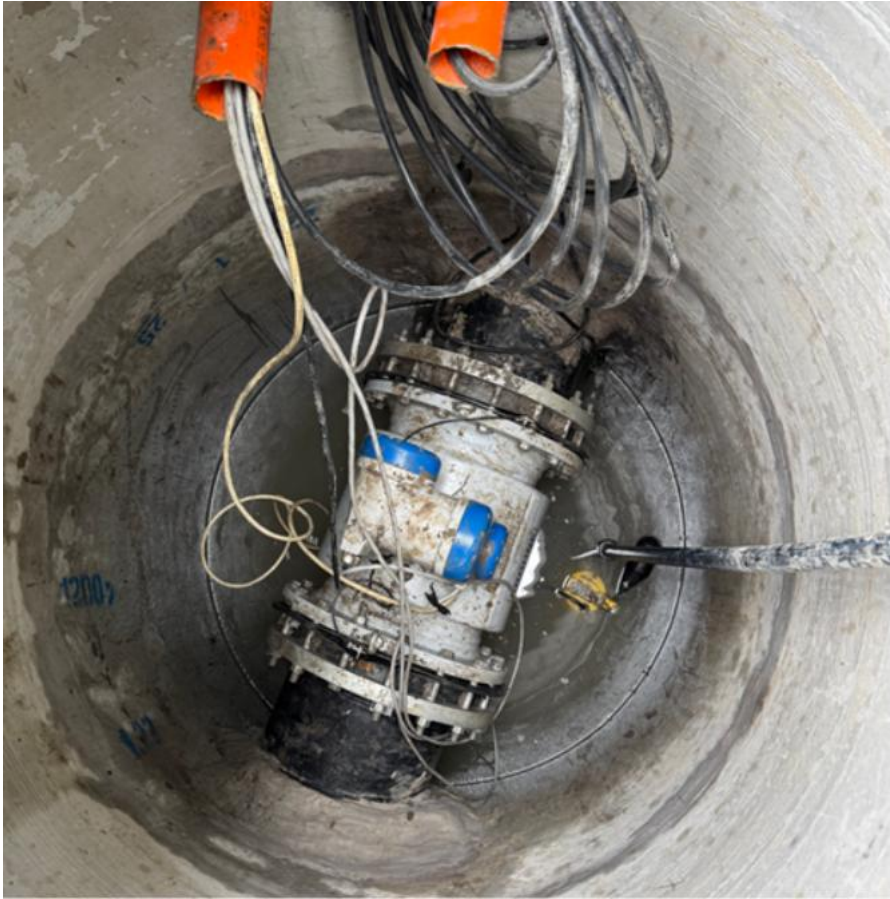
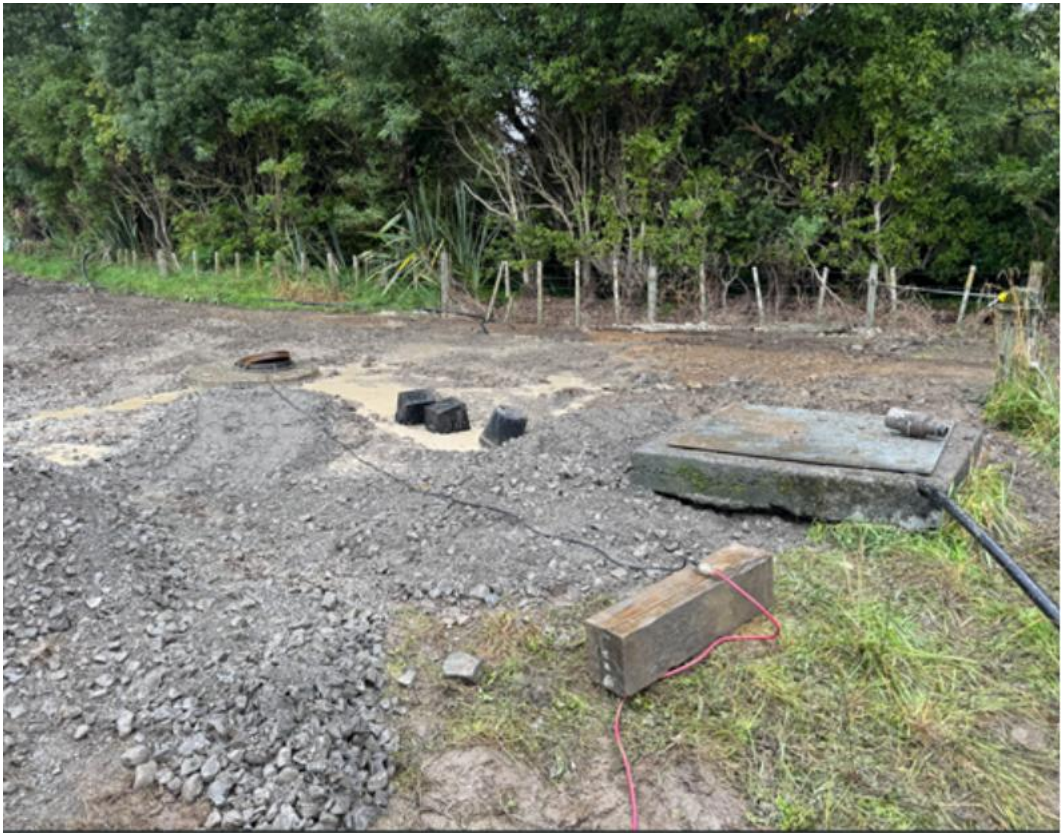
Dannevirke Flow Meter

Max Tarr and Dirtworx were engaged between 23 Feb to 10 Mar for the installation of Dannevirke raw water flow meter at the end of our infiltration gallery. This work is part of TDC's commitment to maintaining compliance with Horizons' intake consent at Dannevirke by having a verifiable flow meter on the raw water intake line. The following photos show the massive work executed onsite to install the flow meter, which was successfully blue tick verified by WaterForce under the supervision of Horizons staff on 31 March

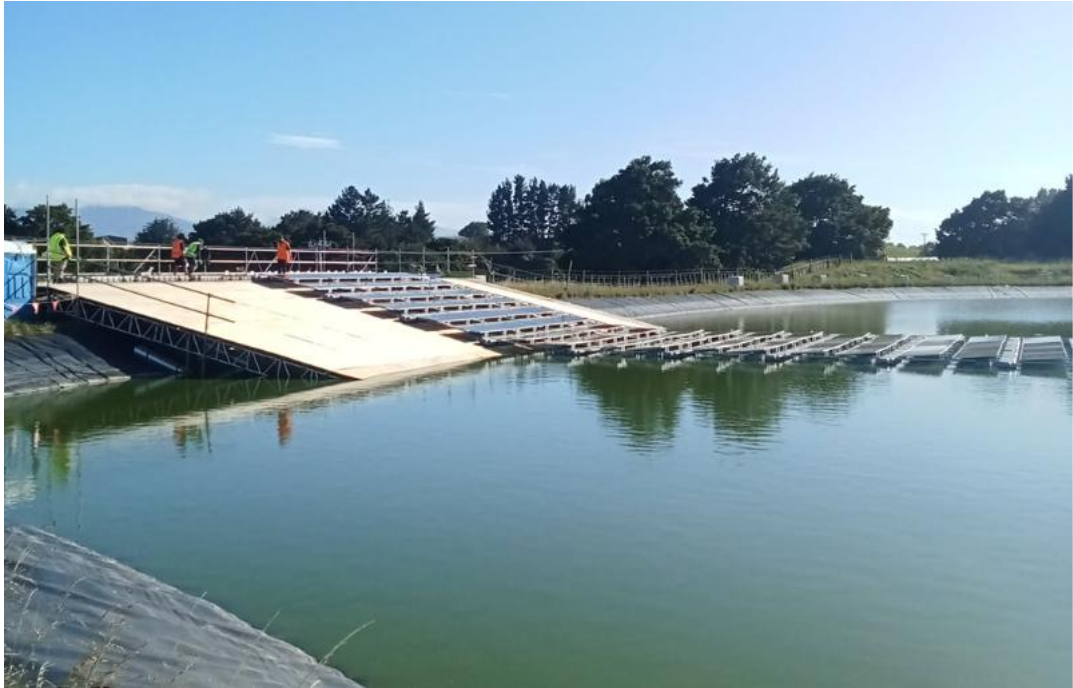
Progress has been made at the Dannevirke solar farm. Adjustments have been made to the scaffolding launch pad to reduce the slope gradient to ease the gradual launch of the solar array. The first solar array commenced construction late March and is expected to be complete by the second week of April. Following completion, the array will be guided into its location across the pond by cables and a boat. A total of five arrays will be installed for this solar farm.

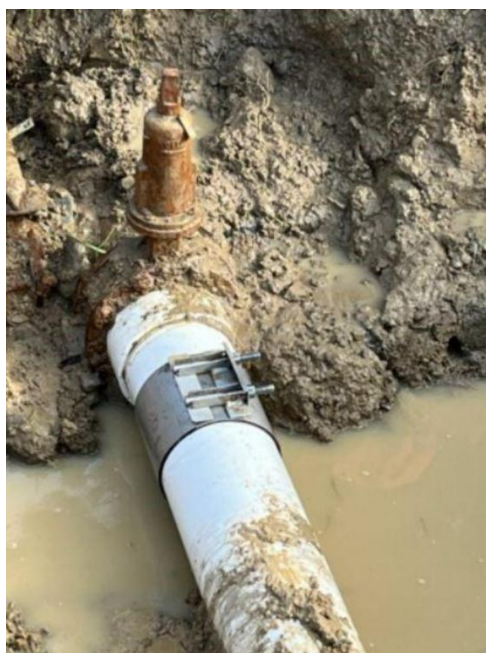
The existing 200 mm mPVC transfer (rising) main conveying treated water from the Pahiatua Water Treatment Plant on Boundary Road to the town storage reservoir at Wakeman Street continues to present a significant reliability risk. A further leak occurred and was repaired yesterday at the tee junction associated with the Titoki Street take-off, reinforcing the ongoing vulnerability of this asset and confirming that failures are not isolated incidents.

This transfer main remains a critical single point of failure within the network, with any significant break having the potential to interrupt supply to the town for extended periods. Repeated leaks further highlight the urgency of replacement, particularly when considered alongside projected population growth identified

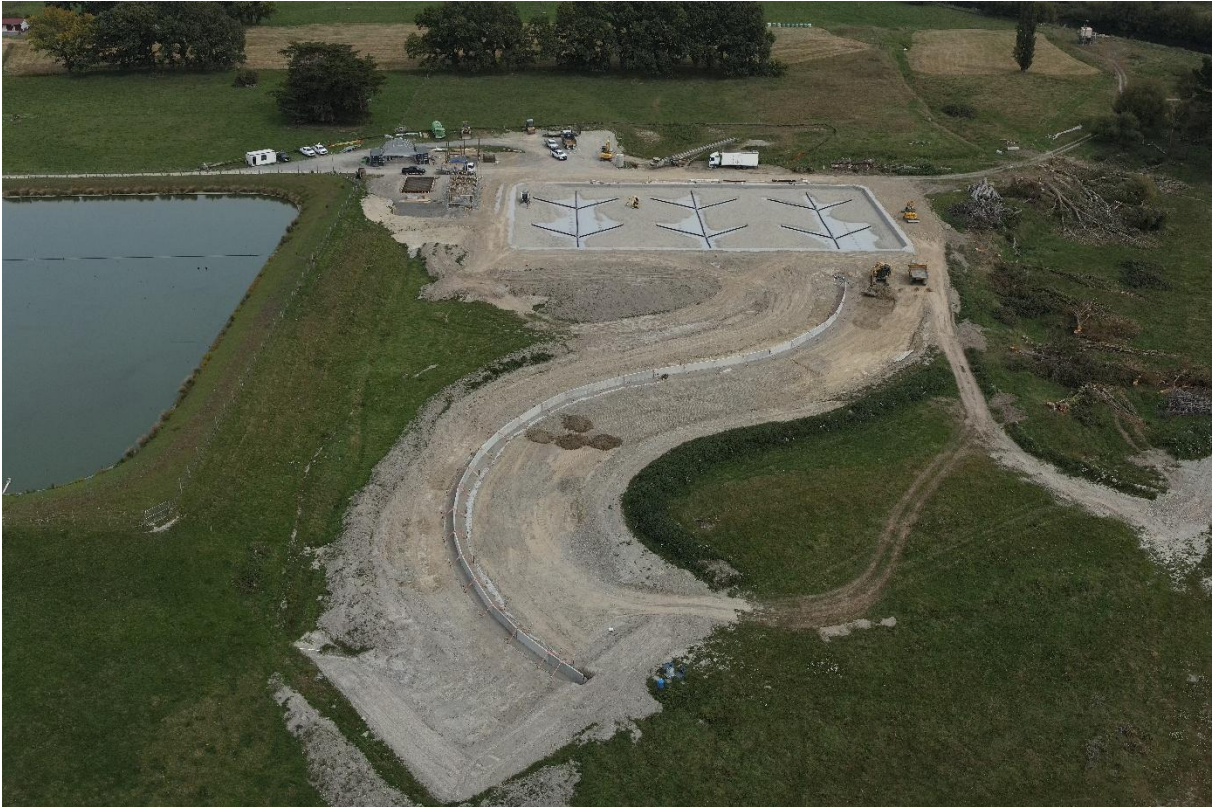
Aerial view of Pahiatua wastewater treatment plant upgrade and wetlands under construction.
